**Grateful Heads  
Beauty Salon**  
Monroe,  
North Carolina

## Challenge

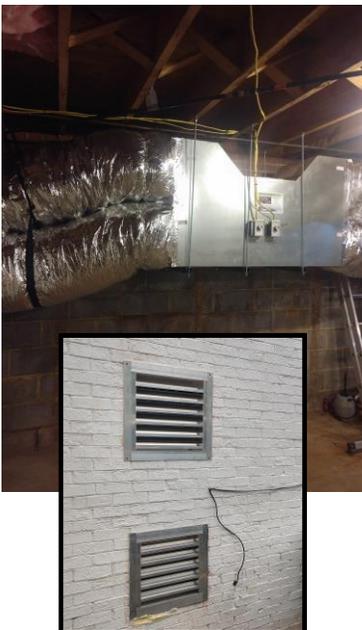
BPE determined that the salon required approximately 900 cfm of air exchange. Consequently, he recommended the BPE-XE-MIR-1000 energy recovery ventilator (ERV) for providing enough outdoor air. The unit was set up in the cellar.

With the addition of an easy-to-use set of controls for adjusting air flow and temperature, this beauty salon is all set to welcome clientele. Not only can they offer a relaxing experience without fumes, but the air displacement also reduces the threat of virus in the air. One high-performance ERV allows Grateful Heads to meet and exceed ASHRAE Standard 62.1 Ventilation Rates for Acceptable indoor air quality.
